Alison Clay Area  
 Kachina Peaks  
 AZ  
 Elevation: 11000 ft  
 Aspect: 330°  
 Specifics:

Scott Krankkala  
 01/26/2019 - 1:30pm  
 Co-ord: 12S 437221W 3911288N  
 Slope Angle: 30°  
 Wind Loading: previous

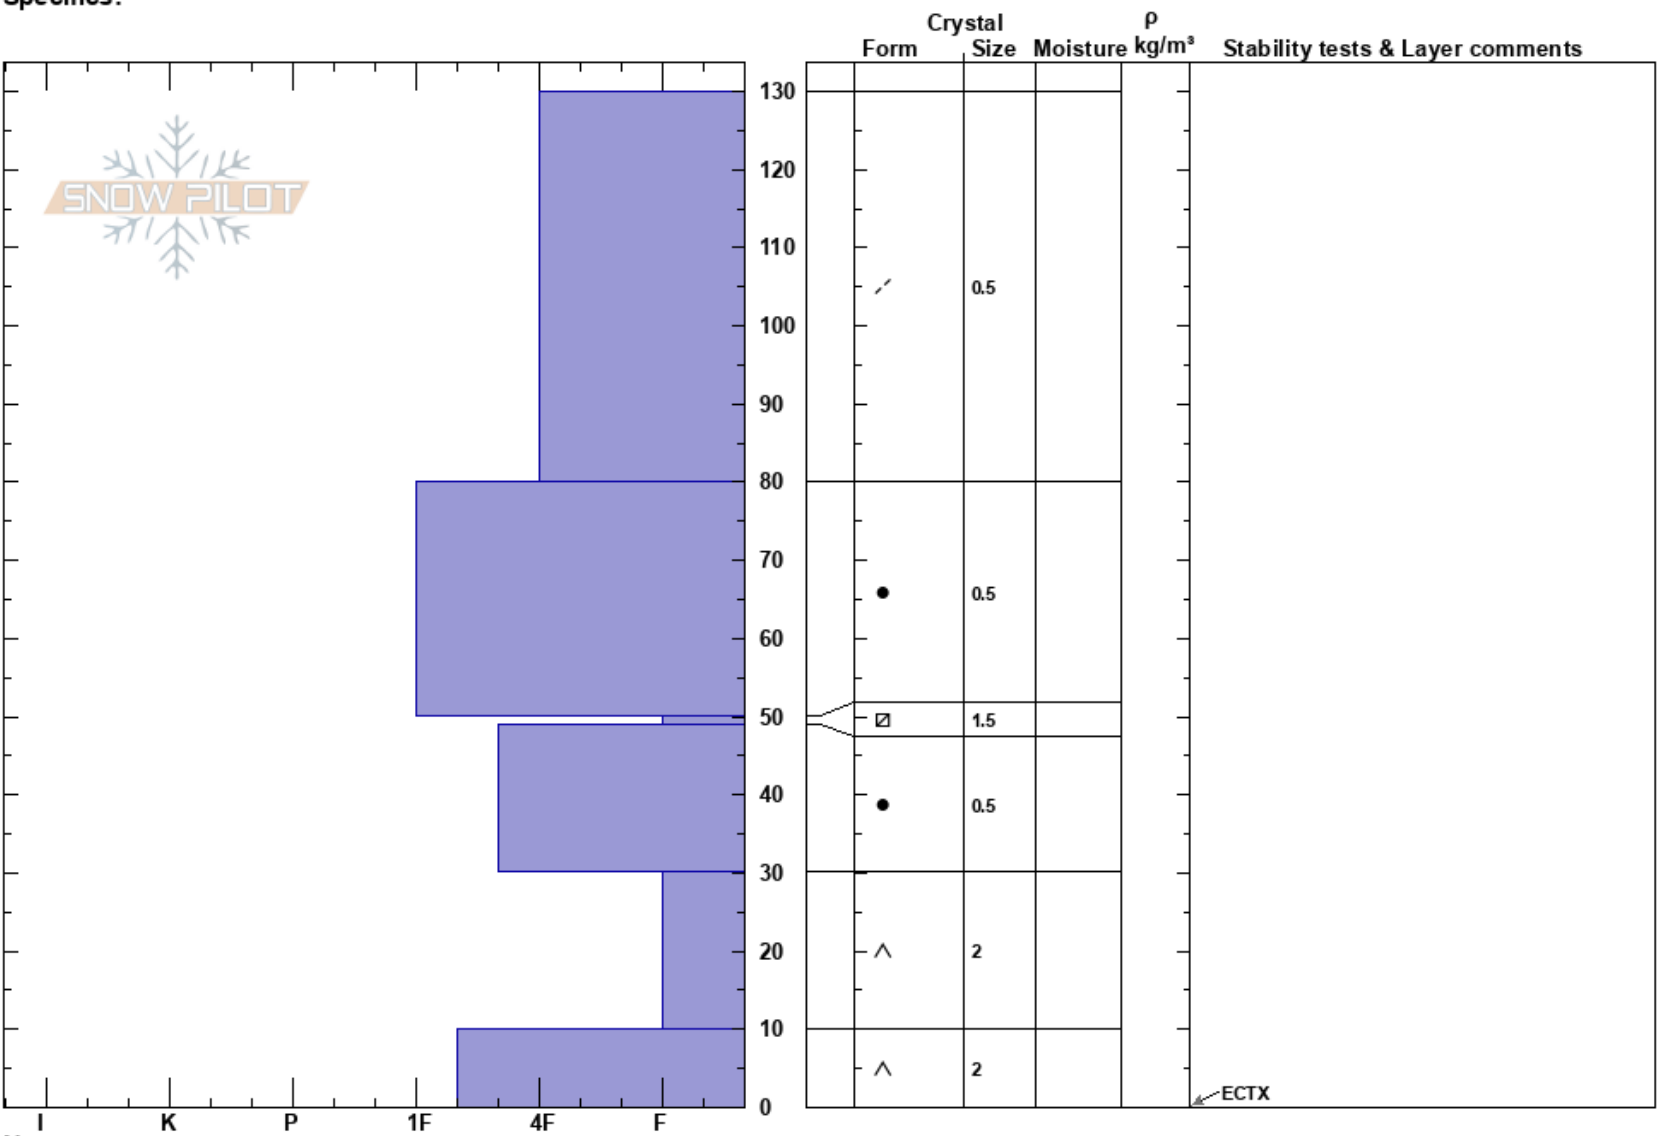
HS:130  
 Layer Notes:  
 50-49cm: Problematic layer

**Notes:** Pit location selected in area with greatest suspicion of instability. NNW facing, moderate snowpack depth, mild wind affect. Hoped to demonstrate instability of persistent weak layers at the ground, and evaluate stability of recent storm events. Was able to identify a thin faceted layer (suspect near surface facets) below strong layers from recent storm events and wind transport. ECT without result during loading steps. Manipulation of column did allow for a clean fracture between two strong layers near surface of different density related to different storm events.

Overall no signs of instability on tour. Warm days and cold nights have added strength to the snowpack and interfaces are continuing to gain strength.
