Cement Creak

Samantha Podhurst

Silverton

02/13/2019 - 3:00pm

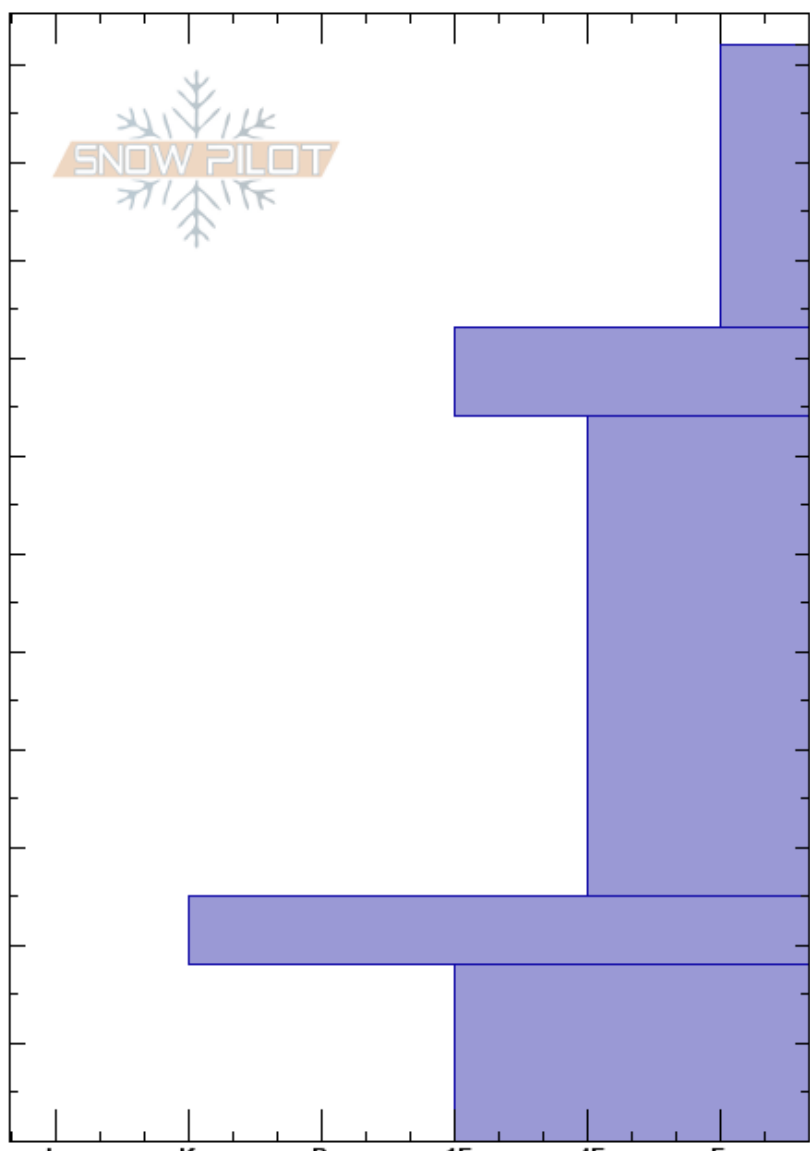
18-0cm: Problematic layer

Specifics: Pit is adjacent to avalanche: crown;

- ↙ PST27100 (End) @5cm
- ↙ ECTP24 @2cm
- ↙ ECTP22 @0cm
- ↙ ECTN24 @0cm

**Notes:** This is a fracture line profile performed on an slide that occurred right off State Highway 110A, on the east side of the road, across from Niagara Gulch. The approximate width was 50', track ran 80', and the length was 100'. The bed surface was a grassy slope, above a creek, with an unsupportive base.
