Ovan Drommenliften Karin Trolin  
Bydalen 05/04/2019 - 11:00  
Sweden  
**Elevation:** 850 m  
**Aspect:** NW  
**Specifics:** Pit is adjacent to avalanche: crown; Cracking; Recent avalanche activity on similar slopes; We skied slope

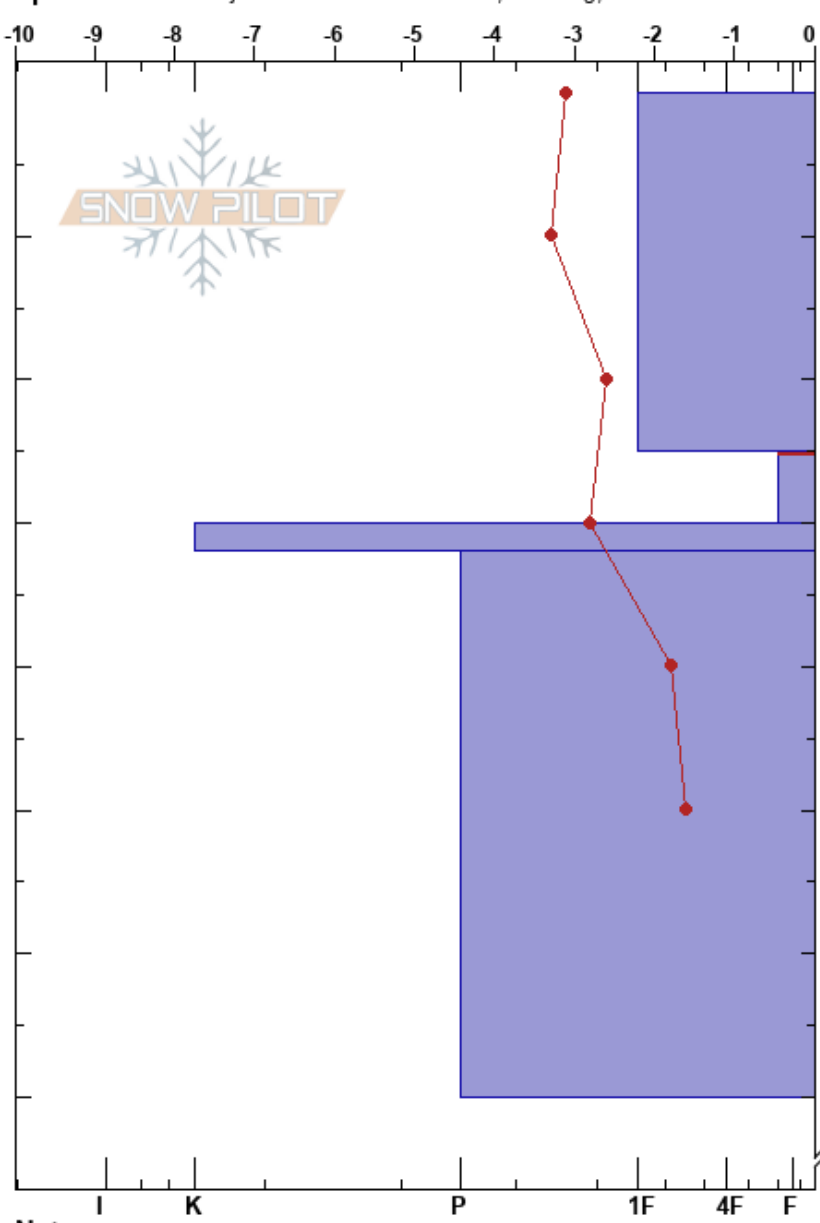
**Stability:** **HS:**150  
**Air Temperature:** -4.1°C **PF:**25 25-30cm:Problematic layer  
**Sky Cover:** OVC  
**Precipitation:** NO  
**Wind:** S Moderate

Crystal		Moisture	$\rho$ kg/m <sup>3</sup>	Stability tests & Layer comments
Form	Size			
/	1.5			ECTN2 @25cm ECTP11 @25cm @DF1.5
⊙⊙
