Mill Creek-Red Mt Pass
 San Juan Range
 CO
 Elevation: 11388 ft
 Aspect: N
 Specifics: Collapsing, localized; Cracking; Recent avalanche activity on similar slopes

Bill Nalli
 11/30/2019 - 1:30pm
 Co-ord: 37.86879N, -107.73414W
 Slope Angle: 33°
 Wind Loading: previous

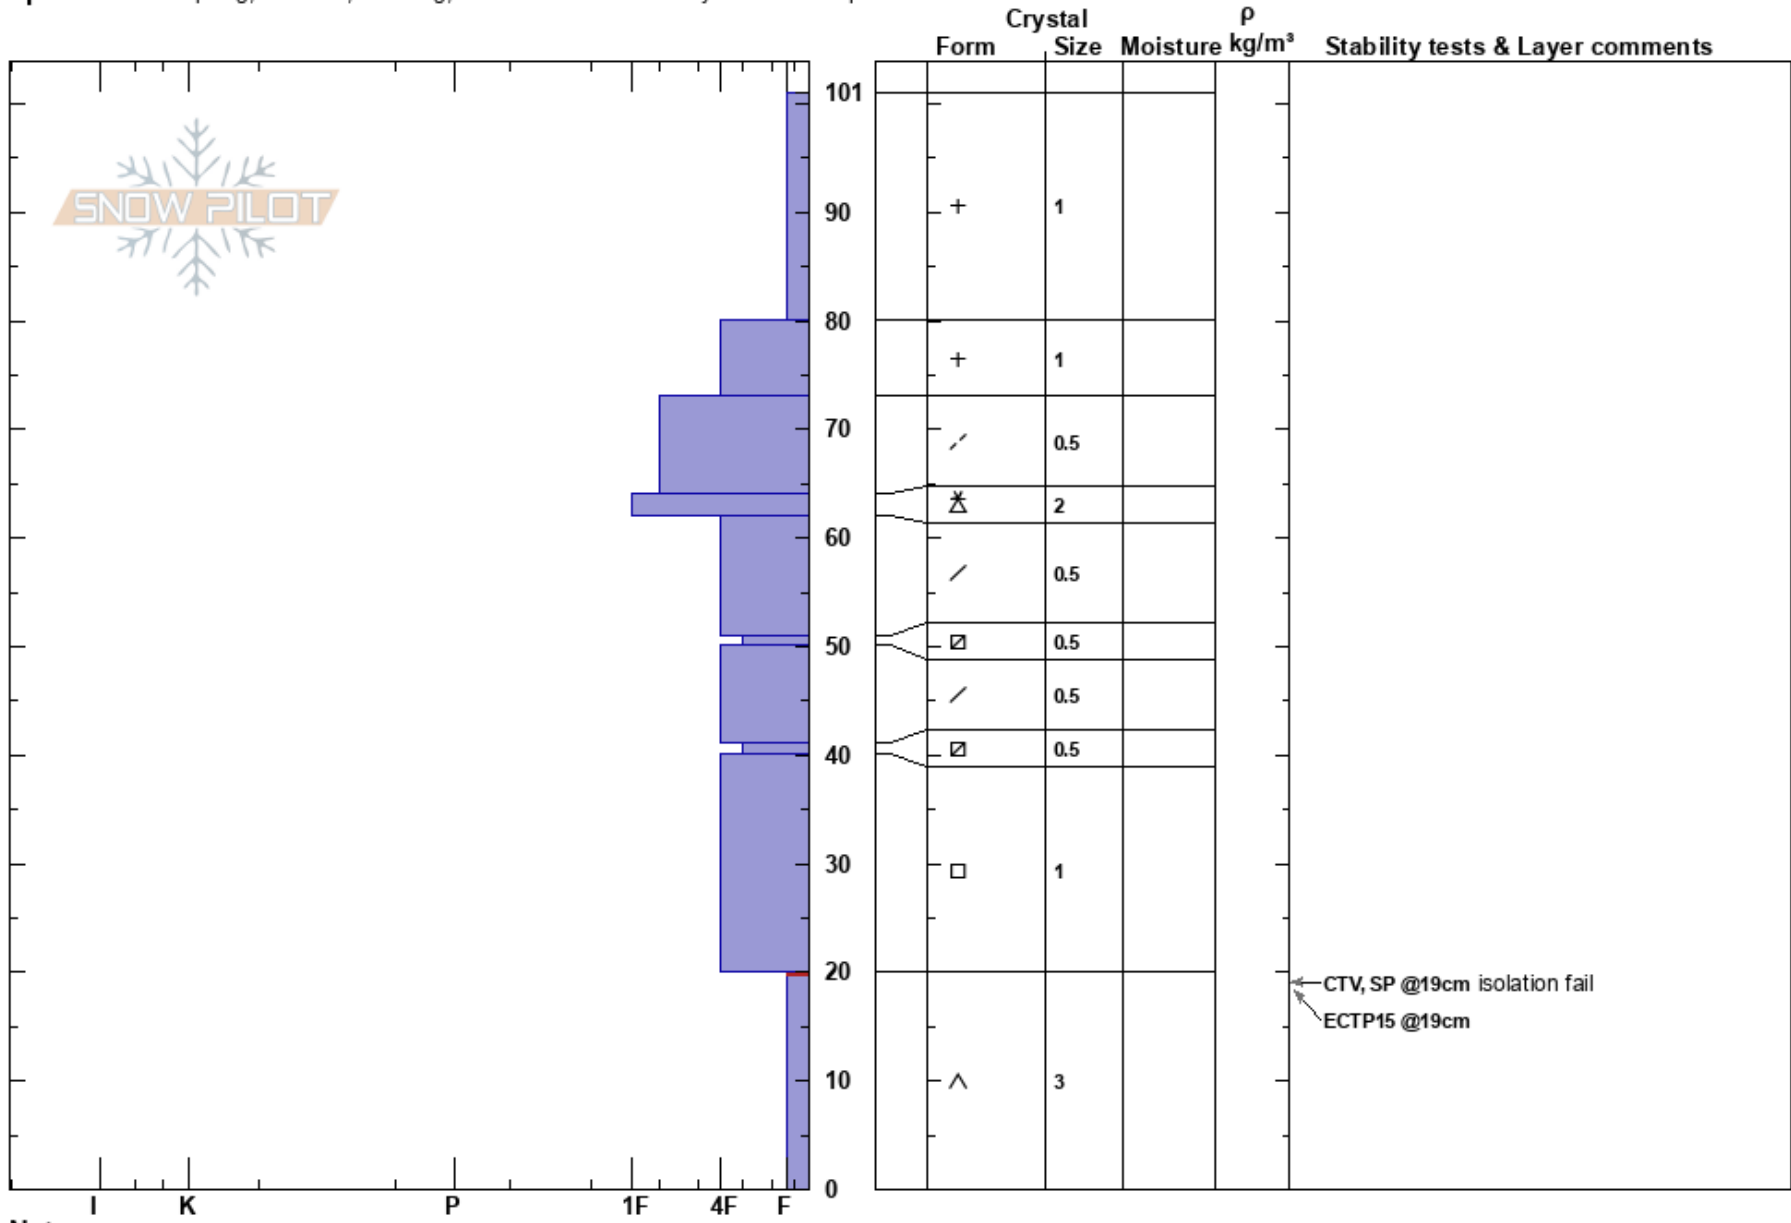
Stability: Poor
 Air Temperature: -16°C
 Sky Cover: BKN
 Precipitation: S-1
 Wind: NW Moderate
 HS: 101
 PF: 100
 PS: 40
 20-0cm: Problematic layer

Notes: Suspect test slope failed after I removed one ski and boot penetrated to ground. Large collapse propagated entire slope back onto 20 deg slope at ridgeline. Stability tests confirmed instability even after slope collapsed. Representative of all NW-N-E aspects near and above treeline where very weak facets exist at the ground.
