Mill Creek-Red Mt Pass  
 San Juan Range  
 CO  
 Elevation: 11388 ft  
 Aspect: N  
 Specifics: Collapsing, localized; Cracking; Recent avalanche activity on similar slopes

Bill Nalli  
 11/30/2019 - 1:30pm  
 Co-ord: 37.86879N, -107.73414W  
 Slope Angle: 33°  
 Wind Loading: previous

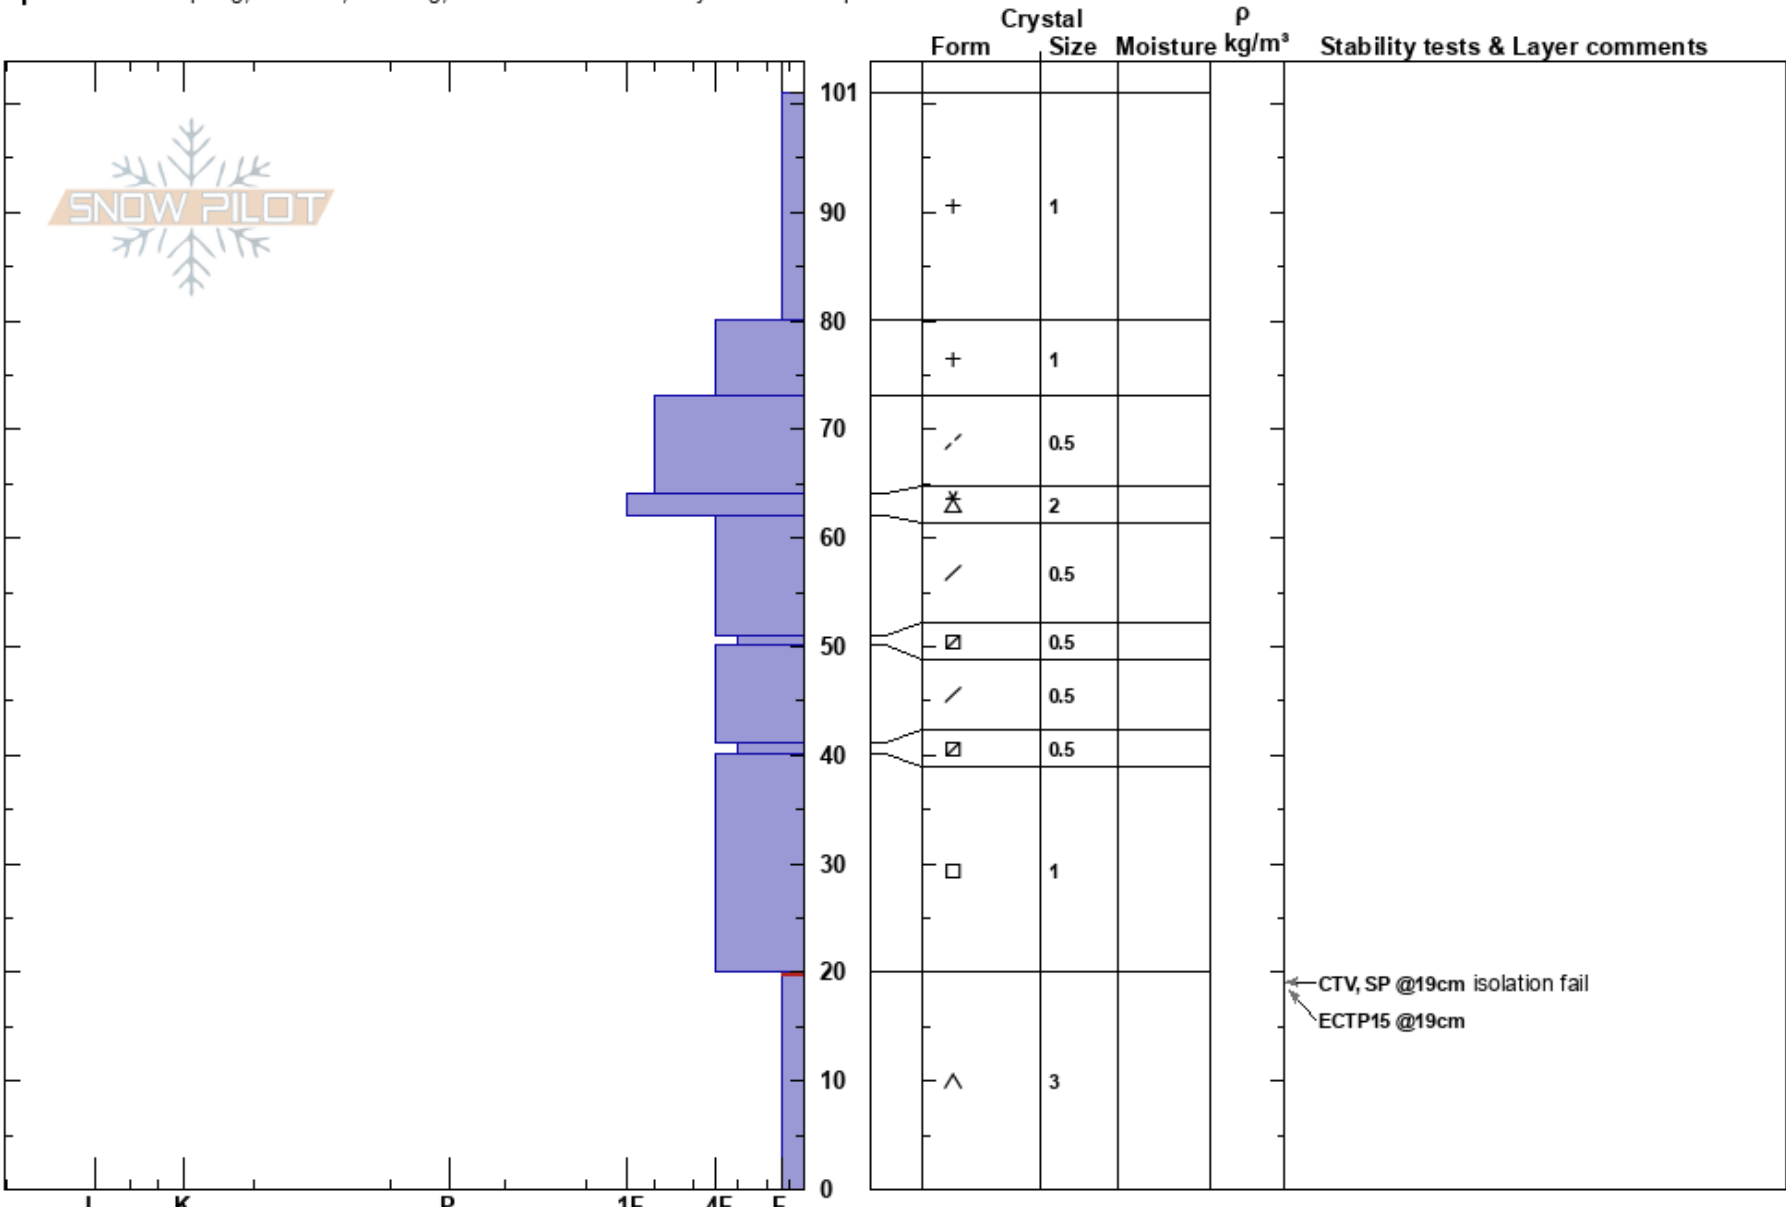
Stability: Poor  
 Air Temperature: -16°C  
 Sky Cover: BKN  
 Precipitation: S-1  
 Wind: NW Moderate  
 HS: 101  
 PF: 100  
 PS: 40  
 20-0cm: Problematic layer

**Notes:** Suspect test slope failed after I removed one ski and boot penetrated to ground. Large collapse propagated entire slope back onto 20 deg slope at ridgeline. Stability tests confirmed instability even after slope collapsed. Representative of all NW-N-E aspects near and above treeline where very weak facets exist at the ground.
