Mill Creek-Red Mt Pass
 San Juan Range
 CO
 Elevation: 11388 ft
 Aspect: N
 Specifics: Collapsing, localized; Cracking; Recent avalanche activity on similar slopes

Bill Nalli
 11/30/2019 - 1:30pm
 Co-ord: 37.86879N, -107.73414W
 Slope Angle: 33°
 Wind Loading: previous

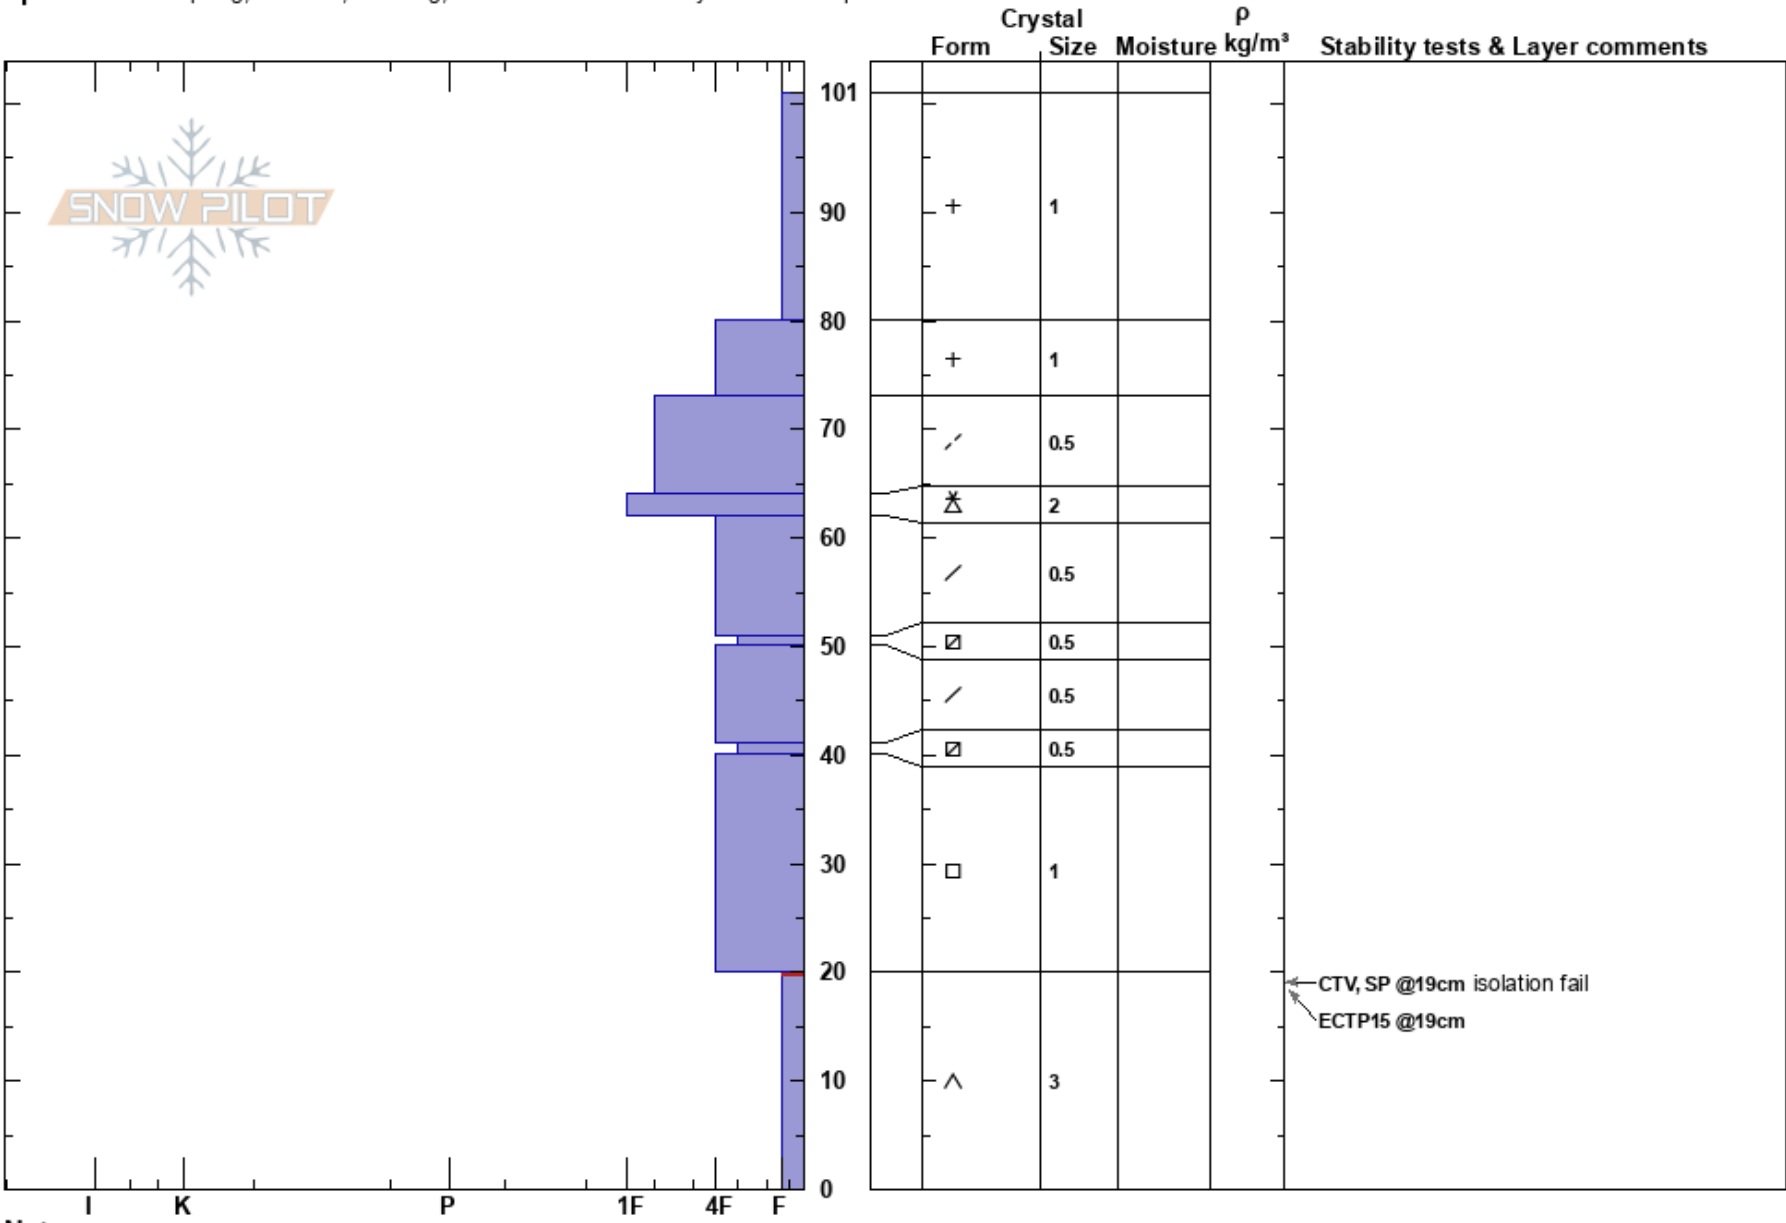
HS:101
 PF:100
 PS:40
 20-0cm: Problematic layer

Notes: Suspect test slope failed after I removed one ski and boot penetrated to ground. Large collapse propagated entire slope back onto 20 deg slope at ridgeline. Stability tests confirmed instability even after slope collapsed. Representative of all NW-N-E aspects near and above treeline where very weak facets exist at the ground.
