Silver mountain check
 Silver Valley Area
 ID
 Elevation: 5955 ft
 Aspect: NW
 Specifics: Pit dug in a Ski Area; Ski tracks on slope; We skied slope

Katrina Roloff
 12/26/2019 - 1:00pm
 Co-ord: 47.48895N, -116.13208W
 Slope Angle: 34°
 Wind Loading: previous

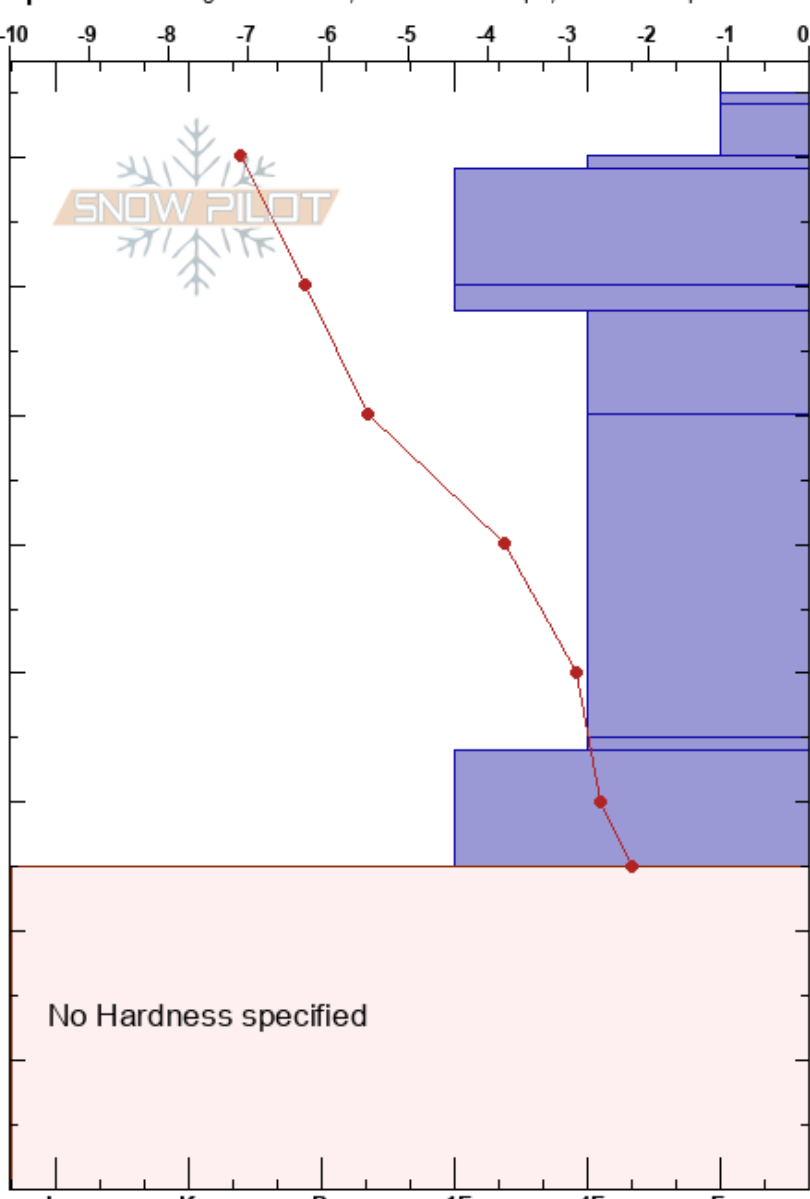
HS:85
 PF:40
 PS:20
 35-34cm: Problematic layer
 25-0cm: Ground- branchy

←ECTP23 @25cm Q2

Notes: We were in a location that may have experienced an avalanche previously, causing basal facets to be more affected by the rain during the 12/19-12/21 storm cycle. We dug to the ground, which was very brushy. The ECT test did not slide freely when it broke at the ground (I would consider shear quality to be Q2 because of this).
