Silver mountain check Katrina Roloff
Silver Valley Area 12/26/2019 - 1:00pm
ID Co-ord: 47.48895N, -116.13208W
Elevation: 5955 ft Slope Angle: 34°
Aspect: NW Wind Loading: previous
Specifics: Pit dug in a Ski Area; Ski tracks on slope; We skied slope

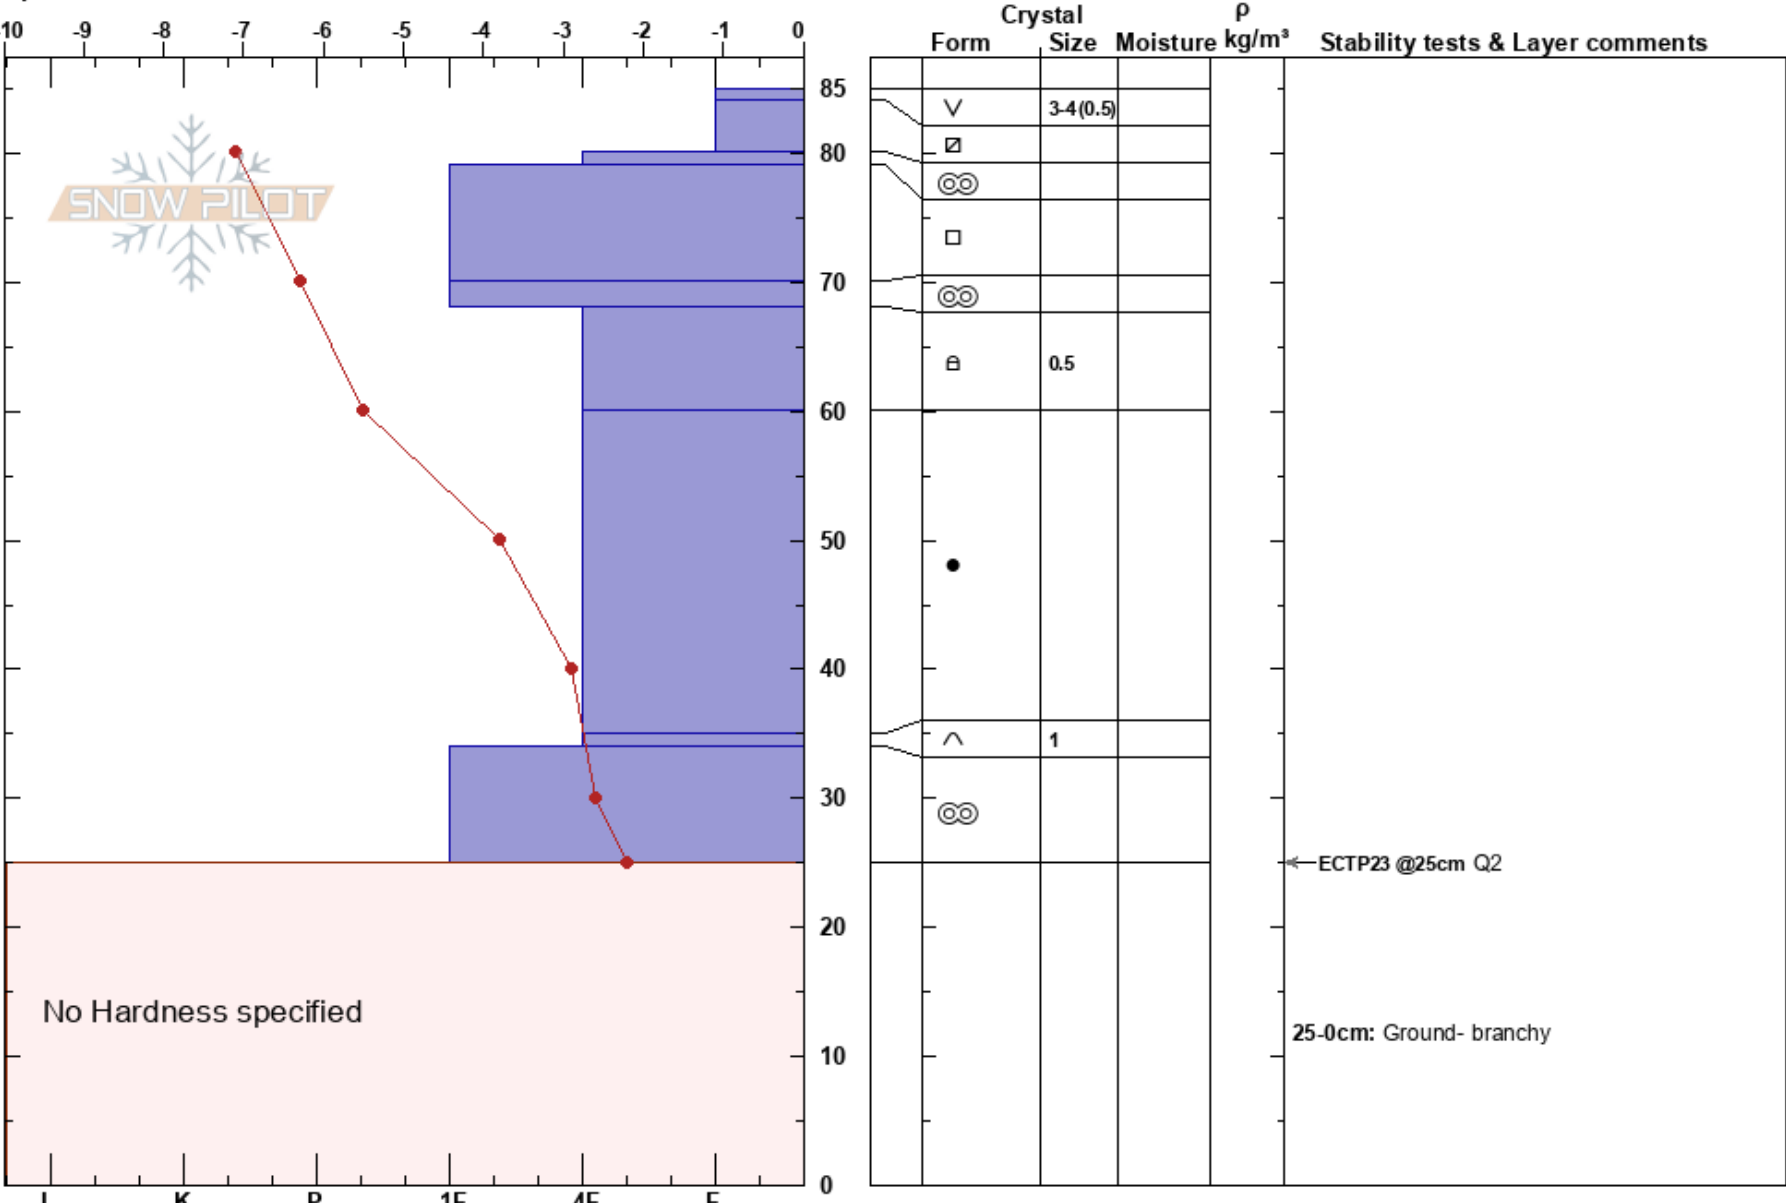
Layer Notes:
35-34cm: Problematic layer
25-0cm: Ground- branchy

Notes: We were in a location that may have experienced an avalanche previously, causing basal facets to be more affected by the rain during the 12/19-12/21 storm cycle. We dug to the ground, which was very brushy. The ECT test did not slide freely when it broke at the ground (I would consider shear quality to be Q2 because of this).
