Silver mountain check
 Silver Valley Area
 ID
 Elevation: 5955 ft
 Aspect: NW
 Specifics: Pit dug in a Ski Area; Ski tracks on slope; We skied slope

Katrina Roloff
 12/26/2019 - 1:00pm
 Co-ord: 47.48895N, -116.13208W
 Slope Angle: 34°
 Wind Loading: previous

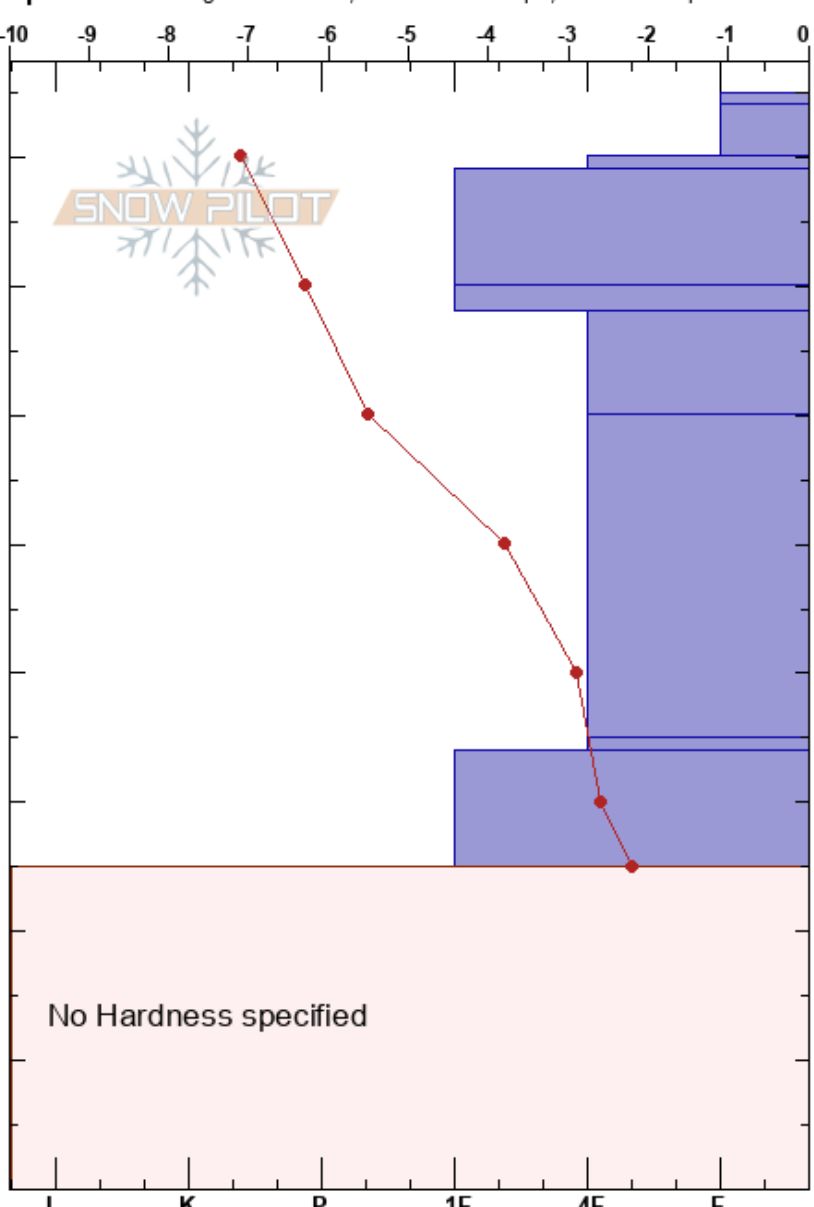
HS:85
 PF:40
 PS:20
 35-34cm: Problematic layer
 25-0cm: Ground- branchy

←ECTP23 @25cm Q2
 25-0cm: Ground- branchy

Notes: We were in a location that may have experienced an avalanche previously, causing basal facets to be more affected by the rain during the 12/19-12/21 storm cycle. We dug to the ground, which was very brushy. The ECT test did not slide freely when it broke at the ground (I would consider shear quality to be Q2 because of this).
