Silver mountain check
 Silver Valley Area
 ID
 Elevation: 5955 ft
 Aspect: NW
 Specifics: Pit dug in a Ski Area; Ski tracks on slope; We skied slope

Katrina Roloff
 12/26/2019 - 1:00pm
 Co-ord: 47.48895N, -116.13208W
 Slope Angle: 34°
 Wind Loading: previous

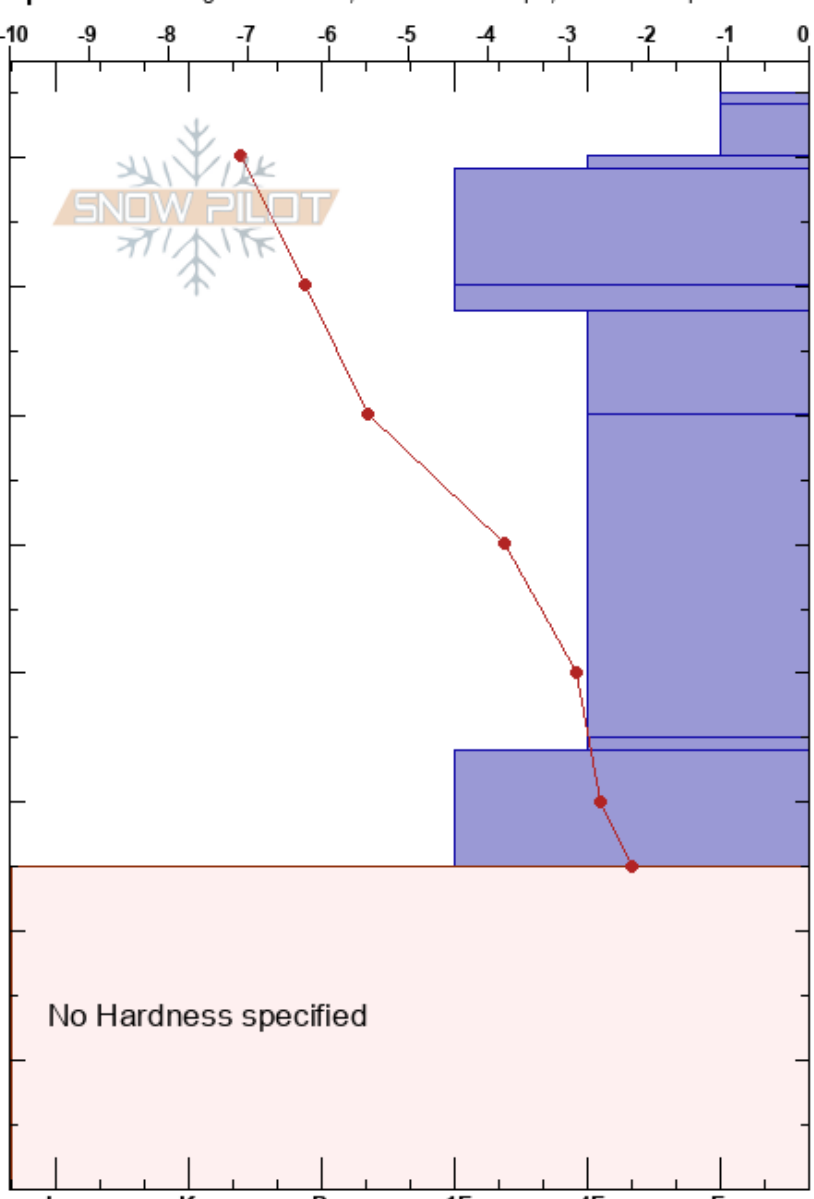
HS:85
 PF:40
 PS:20
 Layer Notes:
 35-34cm: Problematic layer
 25-0cm: Ground- branchy

Form	Crystal Size	Moisture	ρ kg/m ³	Stability tests & Layer comments
V	3-4(0.5)			
∅				
⊙⊙				
□				
⊙⊙				
⊖	0.5			
•				
∧	1			
⊙⊙

←ECTP23 @25cm Q2
 25-0cm: Ground- branchy

Notes: We were in a location that may have experienced an avalanche previously, causing basal facets to be more affected by the rain during the 12/19-12/21 storm cycle. We dug to the ground, which was very brushy. The ECT test did not slide freely when it broke at the ground (I would consider shear quality to be Q2 because of this).
