Bridger Range, Ramp
 MT

Spencer Jonas
 11/11/2017 - 2:45pm
 Co-ord: 45.82853N, -110.93153W

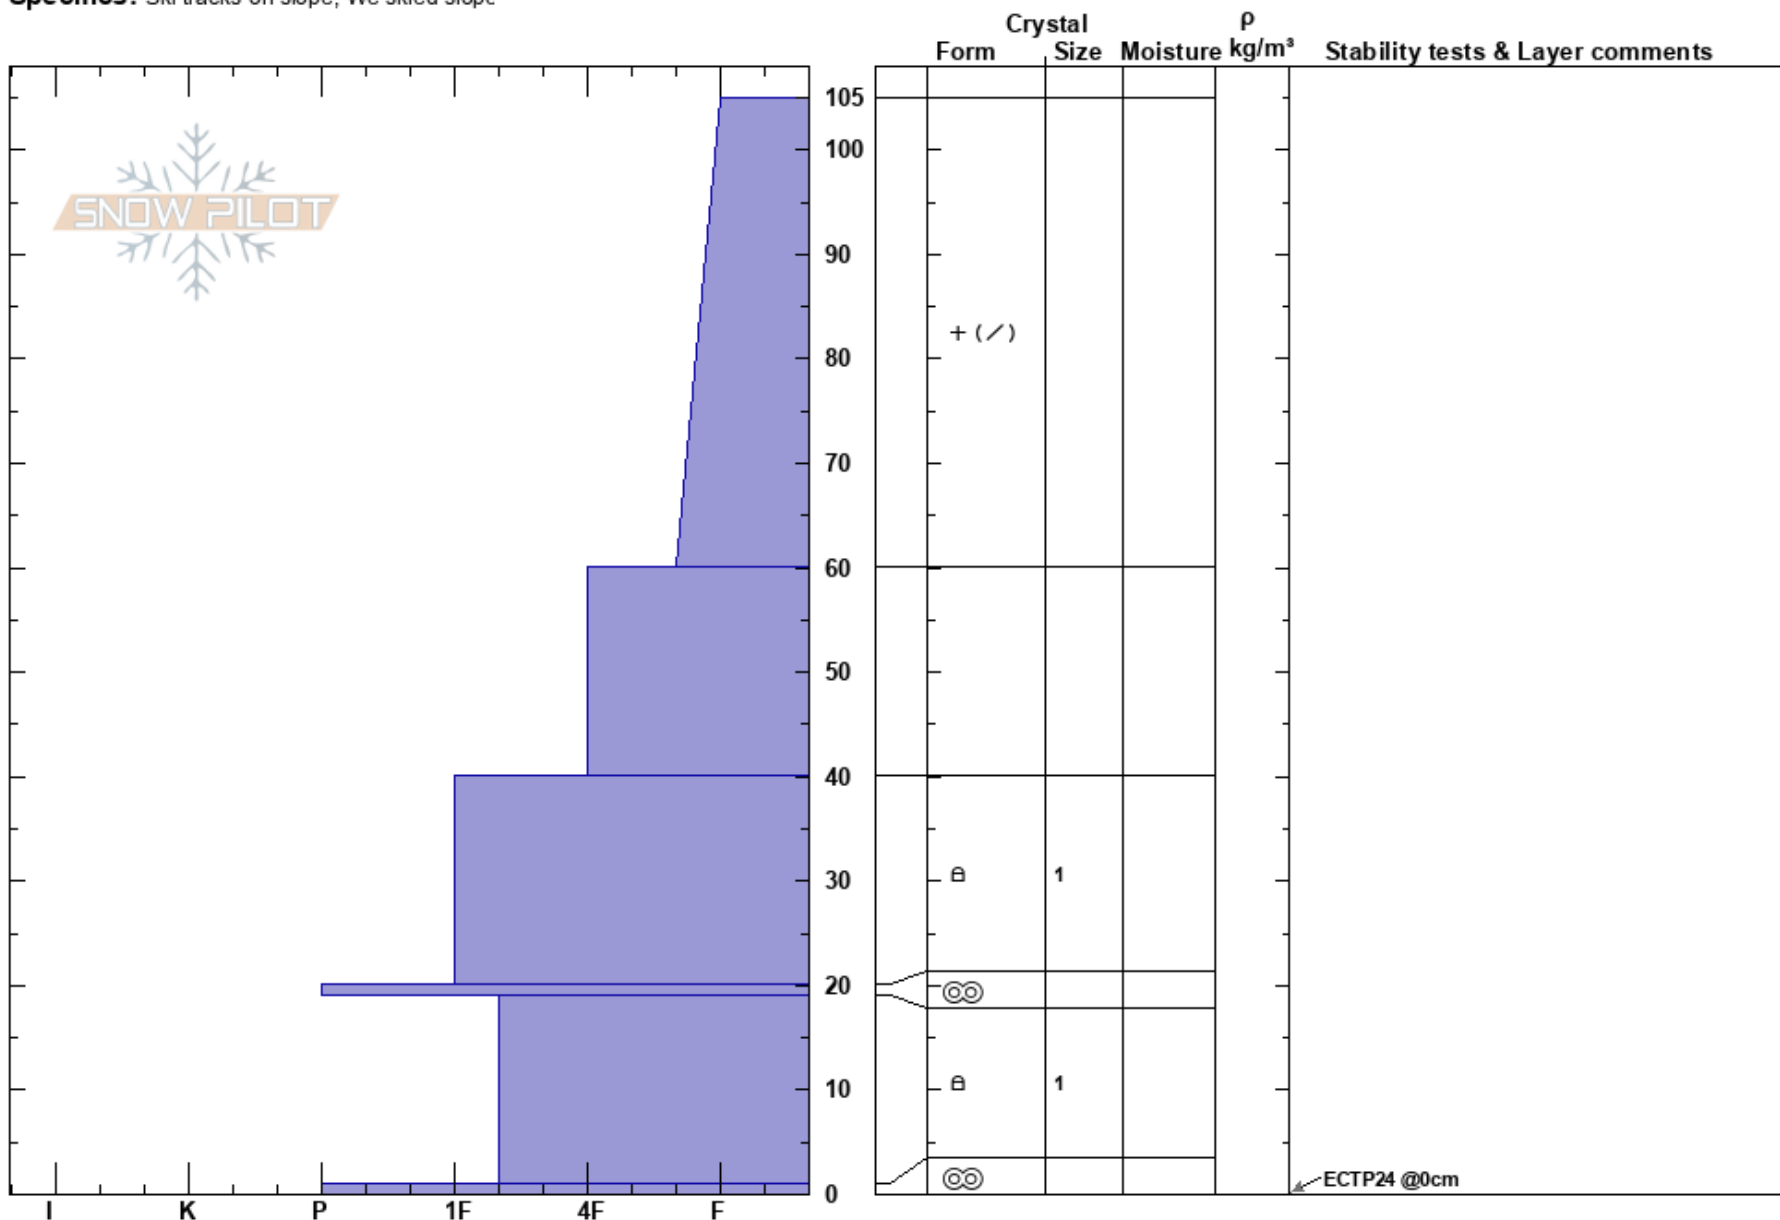
HS: 105
Layer Notes:
 19-1cm: Problematic layer

Notes: There was an air pocket between the ice crust that formed the bottom layer and the ground. The column failed when the ice broke free from the little ground that it was attached to, a small root and rock at the back of the column. Our layer of concern was the old September snow, which showed no sign of instability at its interface. It is hard to interpret the ectp as a sign of instability, it seemed to be more an issue of ground condition specifically beneath the column and not an indicator of overall instability at the
