Bridger Range, Ramp
 MT
 Elevation: 8000 ft
 Aspect: NE
 Specifics: Ski tracks on slope; We skied slope

Spencer Jonas
 11/11/2017 - 2:45pm
 Co-ord: 45.82853N, -110.93153W
 Slope Angle:
 Wind Loading:

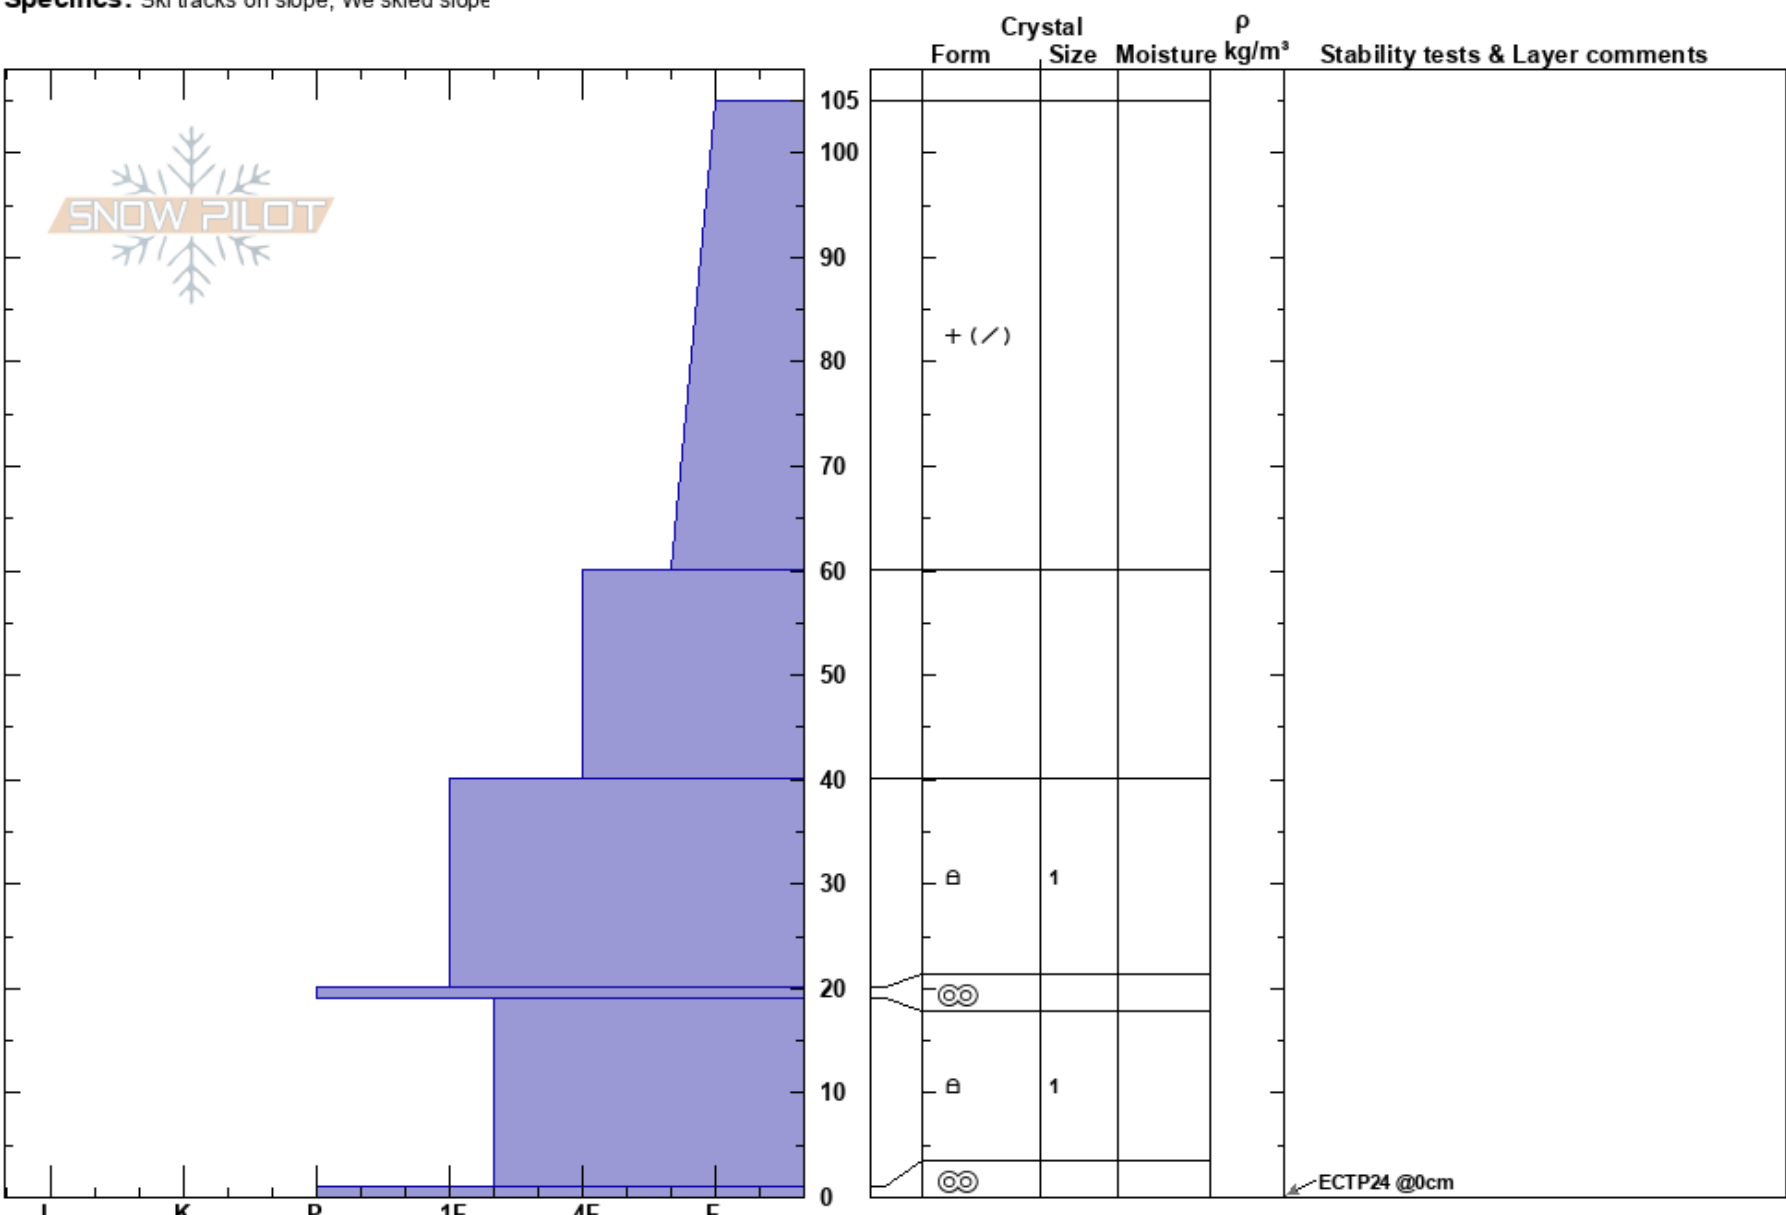
Stability: HS:105
 Air Temperature: 19-1cm: Problematic layer
 Sky Cover: BKN
 Precipitation: NO
 Wind: E Light Breeze

Notes: There was an air pocket between the ice crust that formed the bottom layer and the ground. The column failed when the ice broke free from the little ground that it was attached to, a small root and rock at the back of the column. Our layer of concern was the old September snow, which showed no sign of instability at its interface. It is hard to interpret the ectp as a sign of instability, it seemed to be more an issue of ground condition specifically beneath the column and not an indicator of overall instability at the
