20171215Sister2hi  
 Front Range  
 CO  
**Elevation:** 11662 ft  
**Aspect:** 25°  
**Specifics:** Cracking

Ron Simenhois  
 12/15/2017 - 10:15am  
**Co-ord:** 13S 106W 40N  
**Slope Angle:** 32°  
**Wind Loading:** yes

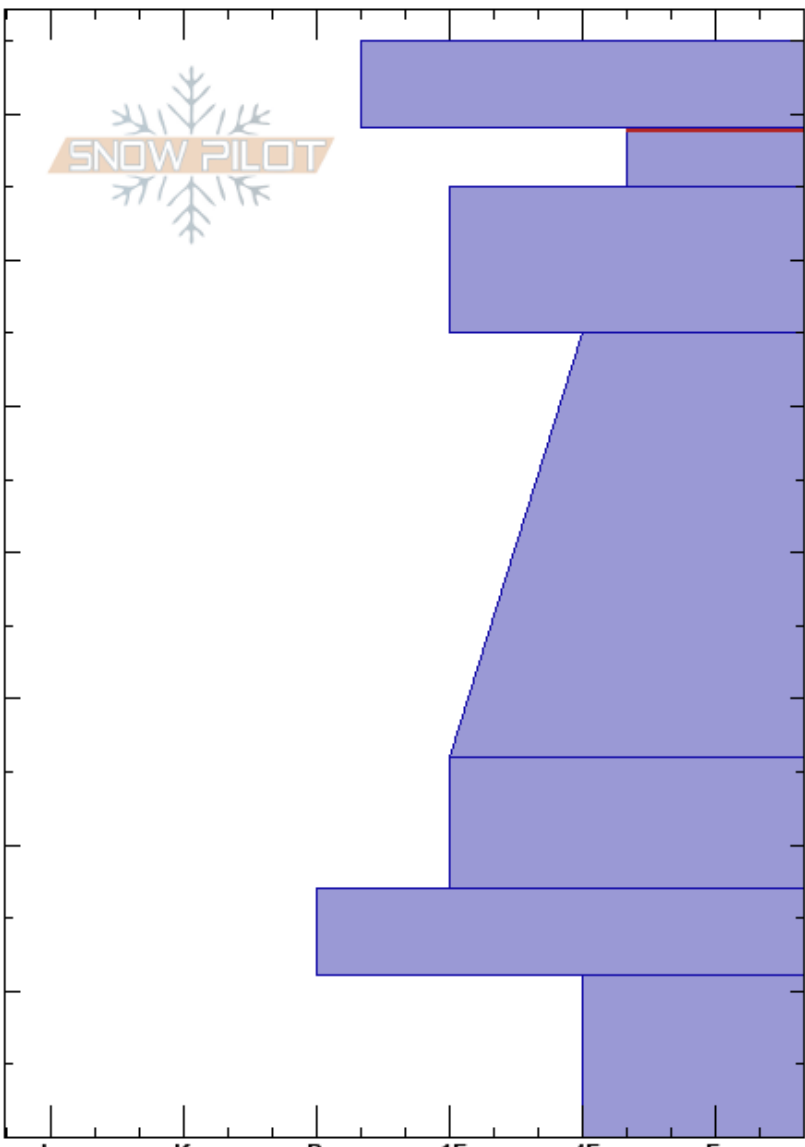
**HS:** 75  
**Layer Notes:**  
 69-65cm: Problematic layer

Elevation (cm)	Crystal		Moisture	$\rho$ kg/m <sup>3</sup>	Stability tests & Layer comments
	Form	Size			
75				196	
70	/	0.3			
68.5	/	0.5			← ECTP2 @ 68.5cm
60	•	0.3			
50					
40					
30					
25	□	0.3			
20	⊙(□)	0.5			
10	^	3.5			
0

**Notes:** Localized wind loaded areas. Cracking about 20m west of the pit location. Cracked were triggered where the wind slab was about 3-4 cm deep
