20171215Sister2hi
 Front Range
 CO
Elevation: 11662 ft
Aspect: 25°
Specifics: Cracking

Ron Simenhois
 12/15/2017 - 10:15am
Co-ord: 13S 106W 40N
Slope Angle: 32°
Wind Loading: yes

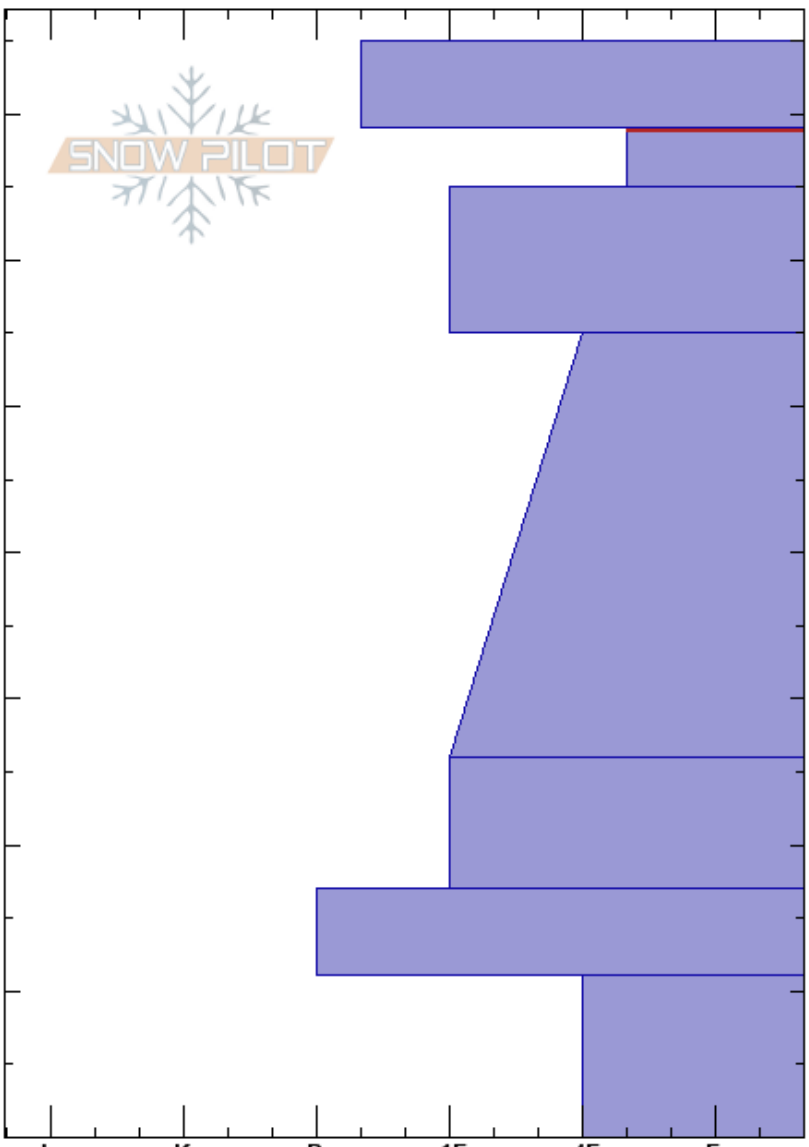
HS: 75
Layer Notes:
 69-65cm: Problematic layer

Depth (cm)	Crystal		Moisture	ρ kg/m ³	Stability tests & Layer comments
	Form	Size			
75				196	
70	/	0.3			
68	/	0.5			← ECTP2 @ 68.5cm
65	•	0.3			
60					
55					
50					
45					
40					
35					
30					
25					
20	□	0.3			
15	⊙(□)	0.5			
10	^	3.5			
0

Notes: Localized wind loaded areas. Cracking about 20m west of the pit location. Cracked were triggered where the wind slab was about 3-4 cm deep
