Ampi Drainage  
 Turoa  
 New Zealand  
**Elevation:** 1800 m  
**Aspect:** SE

Andy Corkill  
 26/08/2023 - 10:00  
**Co-ord:** -39.30542S, 175.53901E  
**Slope Angle:** 35°  
**Wind Loading:**

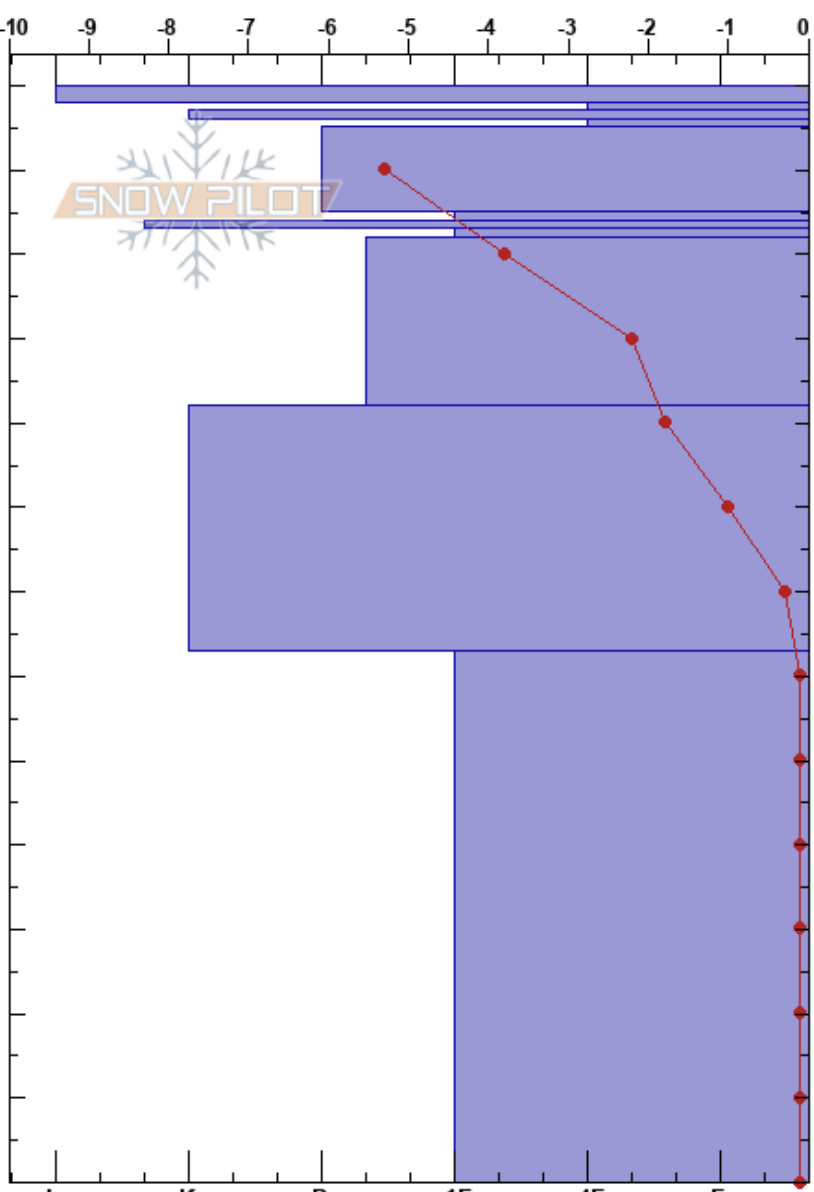
**HS:** 130  
**PF:** 0  
**PS:** 0  
**Layer Notes:**  
 130-128cm: Unbreakable to boot  
 113-112cm: Problematic layer  
 92-63cm: Multiple IFI/MF  
 63-0cm: moist to ground

Height (cm)	Crystal		Moisture	$\rho$ kg/m <sup>3</sup>	Stability tests & Layer comments
	Form	Size			
130	∇				
128	■		D		130-128cm: Unbreakable to boot
125	□	1-3	D		
120	⊙				
115	□	1-3	D		
113	⊕		D		CT11, RP @113cm On FC CT18, RP @113cm On FC
110	□	1-2	D		
105	■		D		
100	□	1-2	D		
95	⊕		D		
92					CT25, BRK @92cm CT22, BRK @92cm
70	○ (■)		D		92-63cm: Multiple IFI/MF
63					
30	⊕		M		63-0cm: moist to ground

**Notes:** Tracking FC layers.
