Ship's Prow Flank  
 Eastern Sierra Nevada  
 CA  
**Elevation:** 10785 ft  
**Aspect:** NE

Clancy Nelson  
 12/24/2023 - 1:00pm  
**Co-ord:** 37.57278N, -118.99982E  
**Slope Angle:** 40°  
**Wind Loading:** previous

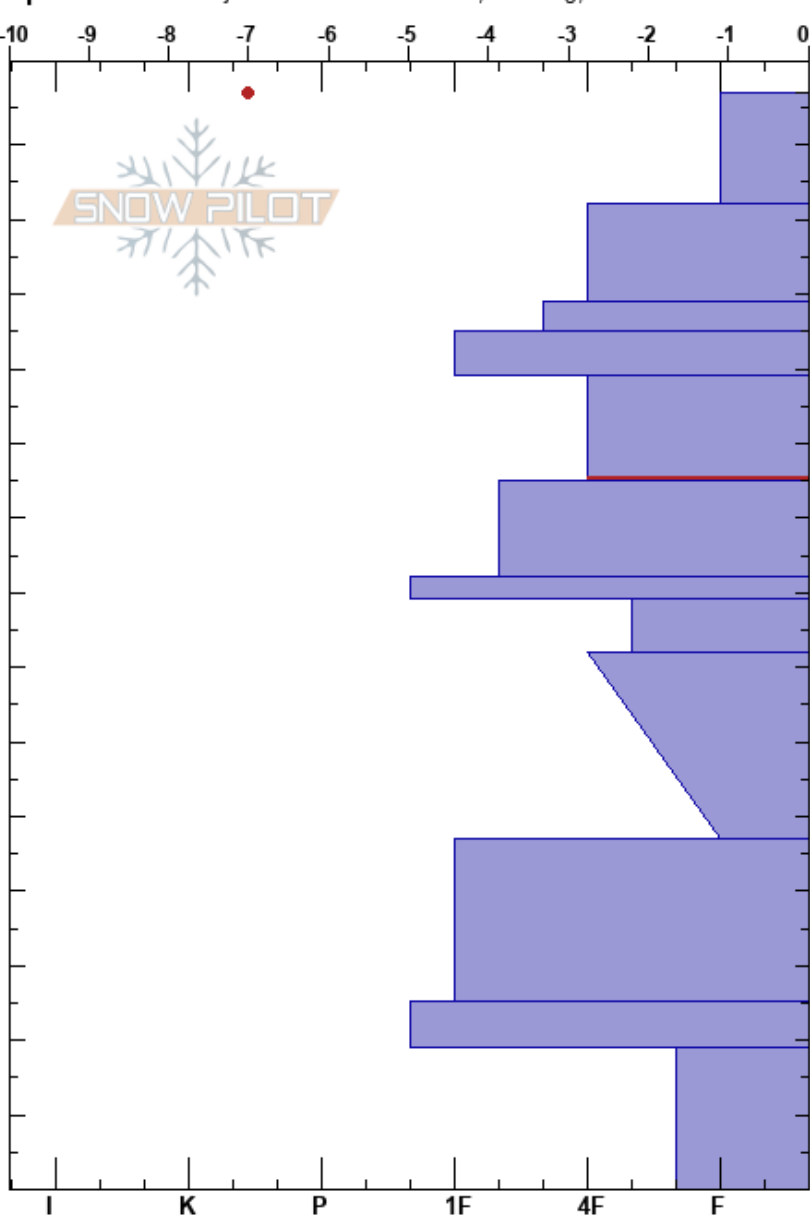
**HS:** 147  
**Layer Notes:**  
 109-95cm: Avy Failure Plane  
 109-95cm: Problematic layer  
 79-72cm: Secondary Failure Plane  
 19-0cm: Some Striations

**Specifics:** Pit is adjacent to avalanche: flank; Cracking; Recent avalanche activity on similar slopes

Depth (cm)	Crystal Form	Crystal Size	Moisture	ρ kg/m³	Stability tests & Layer comments
147	☐	1			
140	∕ (☐)	1			
130	∕	1-2			← ECTN11 @132cm ← CT12, SC @132cm
120	∕	0.5			
110	●	0.3-0.5			← CT20, RP @109cm
100	☐ (∕)	1.5			109-95cm: Avy Failure Plane ← ECTN24 @96cm 3/4 across colum
90	●	0.5			← CT25, SP @96cm
80	☐ (⊙)	1			
70	☐	1			79-72cm: Secondary Failure Plane
60	☐	2			
50					
40	☐	1-2			
30					
20	☐ (⊙)				
10	☐	2-4			19-0cm: Some Striations ← CT22, SC @5cm
0

**Notes:** The ground and bed surface were old snow from last season.
