Marmot SW
 Hatcher Pass
 AK
Elevation: 3557 ft
Aspect: SW
Specifics: Pit is adjacent to avalanche: crown; Collapsing, localized; Cracking; Recent avalanche activity on similar slopes

Andy Paul
 01/07/2025 - 12:45pm
Co-ord: 06V 380926W 6850902N
Slope Angle: 35°
Wind Loading: previous

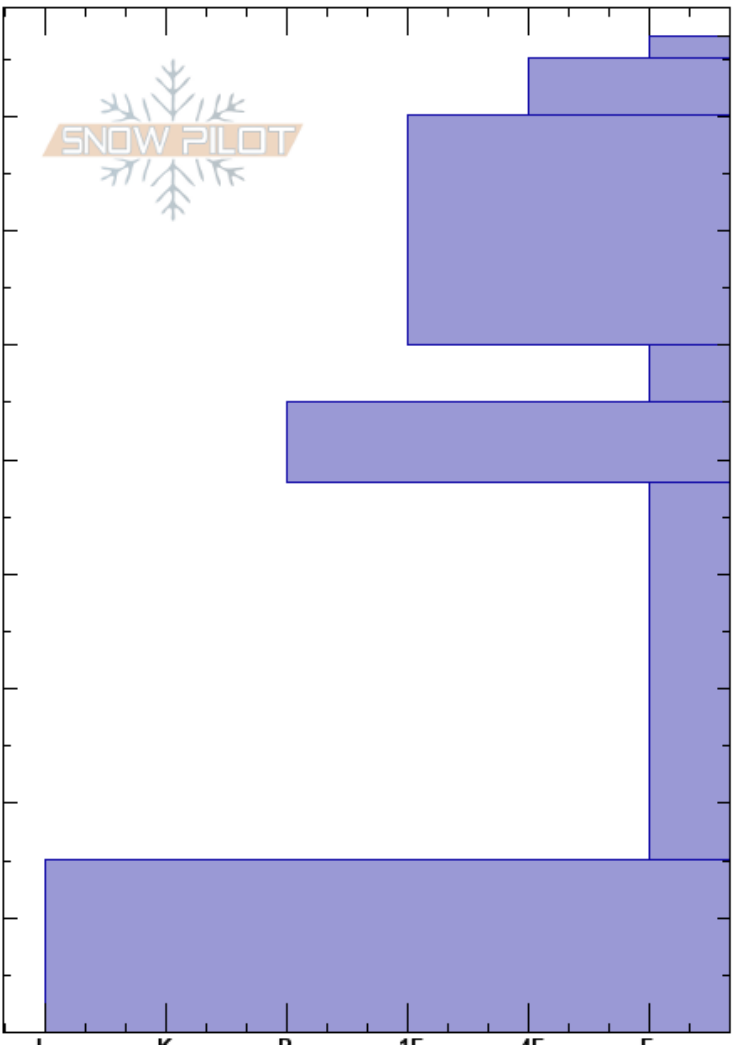
HS:87
Layer Notes:
 60-55cm:Problematic layer

Crystal Form	Size	Moisture kg/m³	Stability tests & Layer comments
+r	2		
+ (X)	1-2		
□			
⊖			
□	1-2		ECTP11 @60cm Failed on facets ECTP15 @60cm
⊖			
^	1-3		
■

Notes: Marmot SW 3,557' 35° HS 87cm ECTP11, ECTP15

This pit was done at a test slope that was triggered while attempting to isolate a snowpit on the second shovel load, indicating sensitivity to human trigger.

At first glance, this appeared to have a 4"-12" crown and was 50' wide by 60' down. After further investigation, it propagated over 100' wide, wrapping around to a more southerly aspect.

The failure plane was 27cm down (60cm above the ground) on 1-2mm facets below 1F to P hard wind slab.
