Happy Face Crown Wall  
 Elk Mountains  
 CO  
**Elevation:** 10960 ft  
**Aspect:** 6°  
**Specifics:** Pit is adjacent to avalanche: crown; Cracking; Recent avalanche activity on similar slopes;

Debbie Kelly  
 02/14/2018 - 10:45am  
**Co-ord:** 39.13560N, -106.80685W  
**Slope Angle:** 30°  
**Wind Loading:** previous

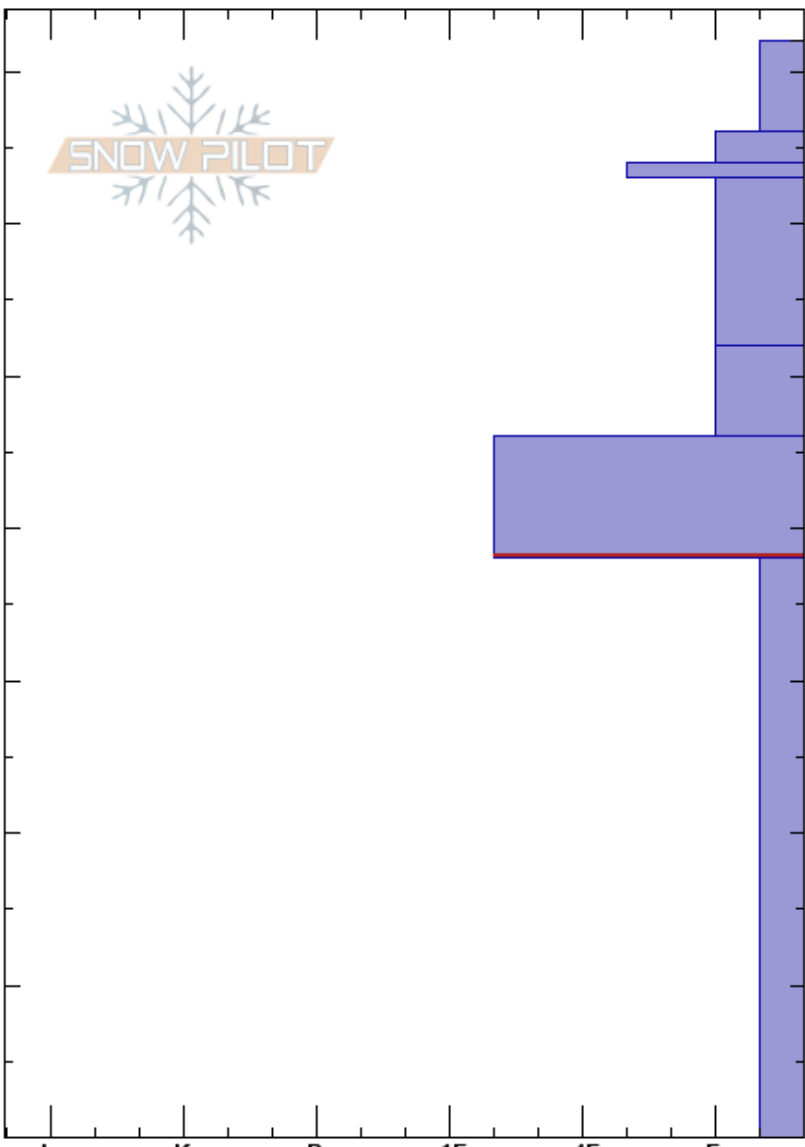
**HS:** 72  
**Layer Notes:**  
 46-38cm: bed surface at bottom  
 46-38cm: Problematic layer  
 38-0cm: Not to ground

Crystal Form	Size	Moisture	$\rho$ kg/m <sup>3</sup>	Stability tests & Layer comments
+				
+				
+ ( / )				
/				
•	0.3			
□	2			46-38cm: bed surface at bottom
□ ( ^ )	4-6			38-0cm: Not to ground

**Notes:** Crown Wall profile post R3, D2.5 (13 Feb); widespread cracking observed: Obs: Steve Schreiber, Debbie Kelly
