Burnout BNSF Avalanche Safety Lewis Range

12/20/2017 - 1:00pm

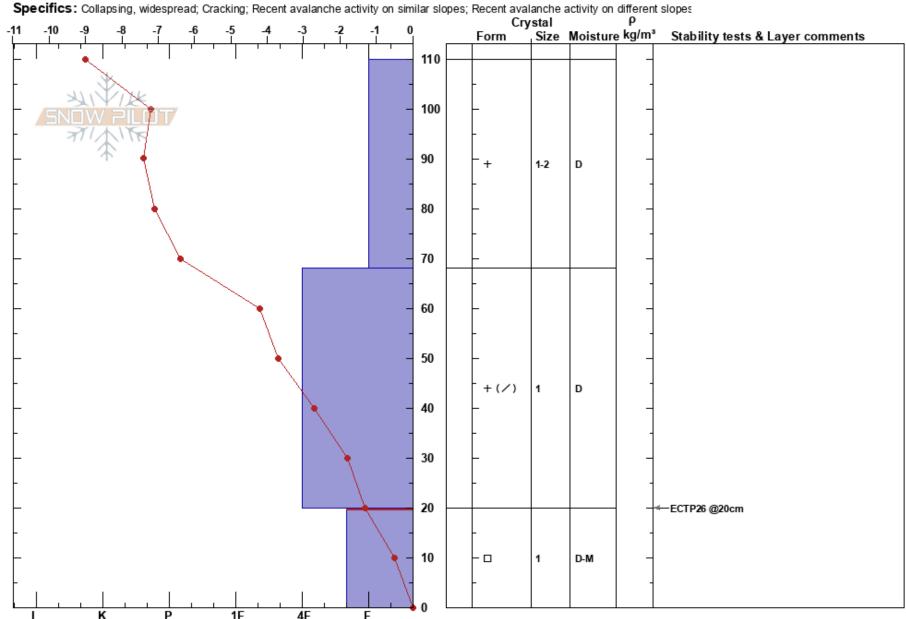
Notes: Widespread collapsing and cracking from rail grade to pit location.

Stability: Poor Air Temperature: -10°C Sky Cover: FEW

HS:110

Layer Notes: PS: 80 20-0cm: Problematic layer
